# Paradise Dam Downstream Fishway Monitoring Program

Final V1.1 Report  
February 2012

for Burnett Water Pty Ltd, contract dated 5 September 2007

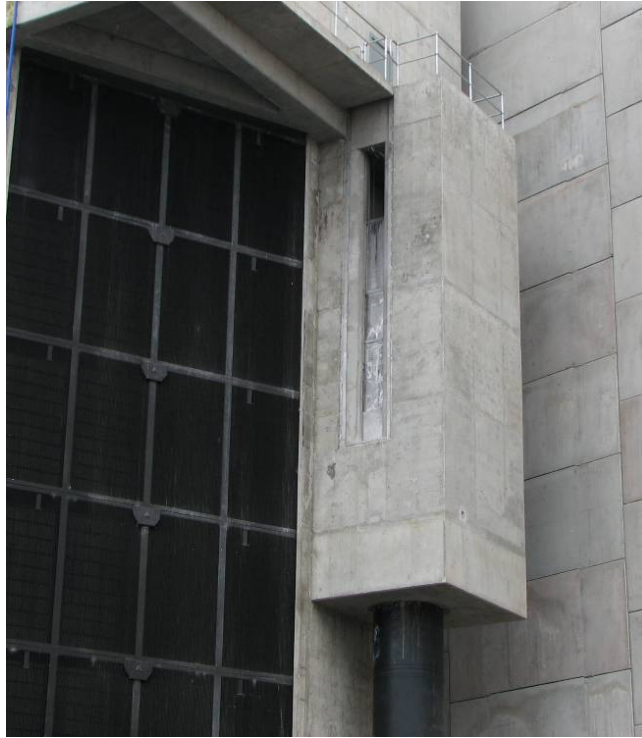
**Figure 2** The downstream fishway prior to filling of the dam showing the fishway entrance slot, the fishlock chamber and the standpipe. Note the adjustable quad leaf gate in the fishway entrance slot.

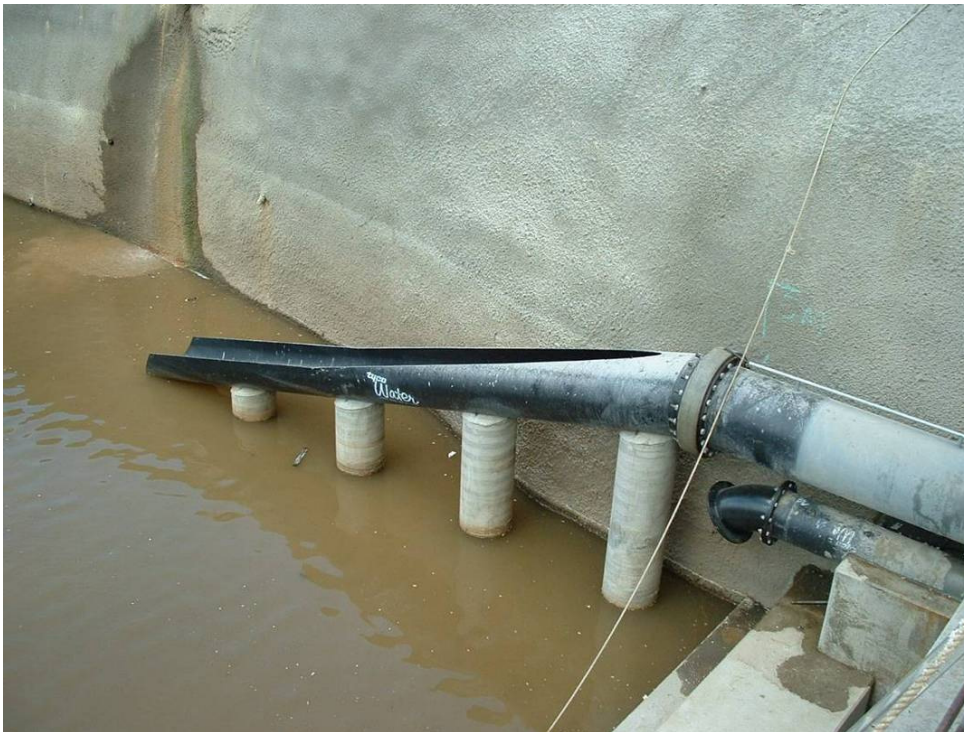
**Figure 3** The exit chute of the downstream fishway at Paradise Dam

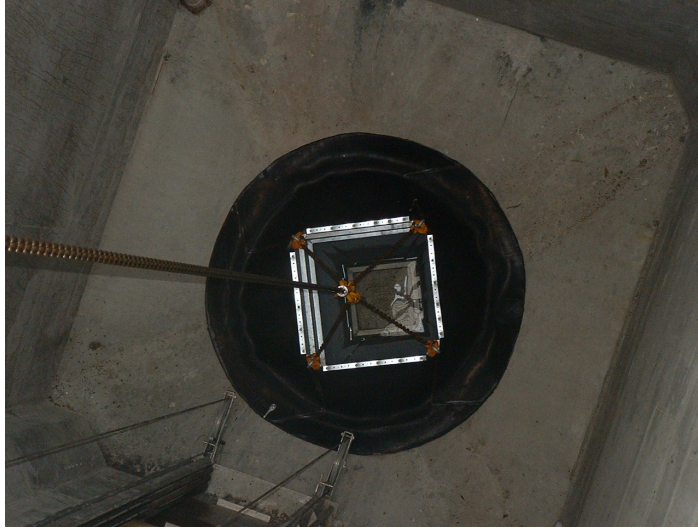
**Figure 5** The sampling trap in the downstream fishlock chamber.

To monitor the downstream fishway, the fishlock was set in attraction mode for a predetermined time. The depth of water across the fishway entrance slot and headloss was set at the optimum level as determined during testing and initial operation of the fishway. The downstream exit chute sampling net was placed into position at the throat of the downstream exit chute and tethered. Once the attraction phase had ended, the drain cycle commenced and water was lowered in the standpipe. After a short period, the quick release gate valve opened and water flowed down the pipe and into the exit chute sampling net. This occurred for a period of two minutes. As soon as the flow ceased the net was lifted from the throated opening, raised vertically and shaken to ensure fish were trapped into the mesh cod end. Fish were then removed through the drawstring opening and placed into a live well. Fish were then sorted, measured and released into the main irrigation release channel.

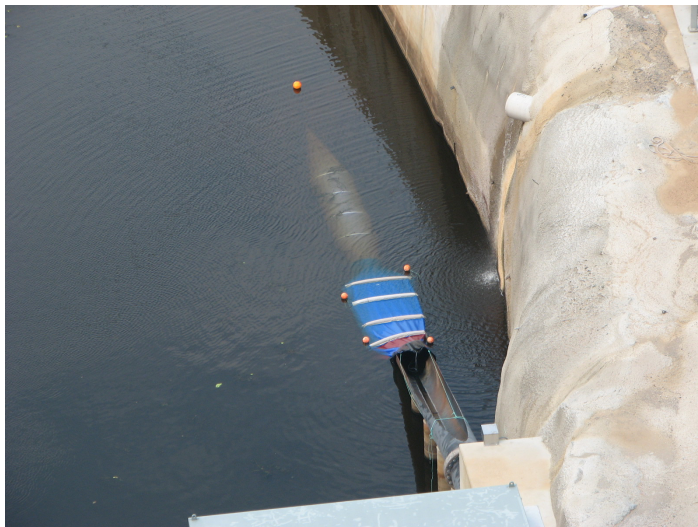
**Figure 6** The exit chute sampling net at the downstream fishway exit chute.

The exit chute sampling net consisted of three sections. The first section comprised of a 1000 mm long throated circular entrance designed to fit inside the exit chute pipe. This section was solid PVC and spread outwards to meet the next section. The second section consisted of a 5000 mm (length) x 1800 mm (width) x 1800 mm (height) rectangle chamber with solid PVC top and bottom panels and 3mm mesh side panels. Floats and weights were attached at all four corners of this section to maintain its shape prior to water entering. This section was designed so that water energy could be dissipated in a large area and through the sides of the rectangular chamber. This was to reduce the water velocity and potential impacts that would occur to fish as they were captured in the exit chute sampling net. The end of this section was solid PVC on all sides and narrowed to 1000 mm where the next section attached. The third section consisted of a cylinder of 4 mm knotless mesh, 5000 mm in length and 1000 mm in diameter. This narrowed at the end to a conical point where a drawstring was located for the removal of fish. A float and weight were attached at the end of the sampling net to hold its position and structure prior to water being released.

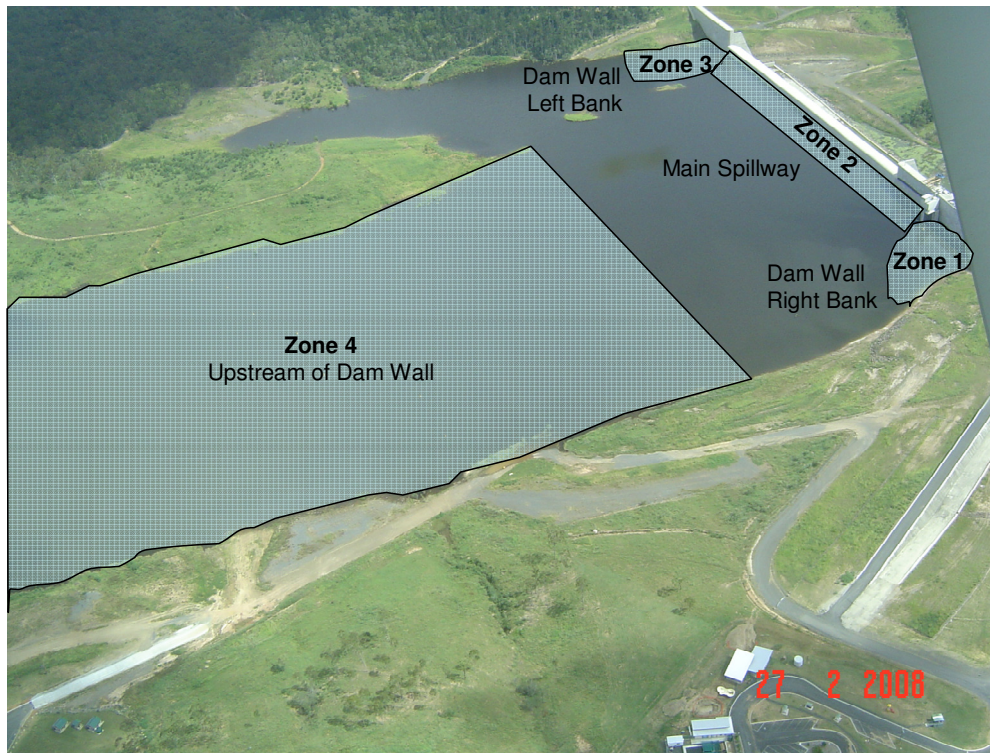
**Figure 7** Areas boat electrofished to determine zones of fish aggregation.

Boat electrofishing was conducted using a 5.3 m boat fitted with a 7.5 kW Smith–Root electrofisher that produced a pulsed DC waveform. Two operators at the bow of the boat collected stunned fish with dip nets and placed them into an aerated tank of water until processed; a third person operated the boat and the electrofisher controls. A number of areas above the dam wall were specifically targeted to determine zones of fish aggregations, descriptions are provided below in Figure 7. Comparisons with fish species and numbers collected by other methods were also made. Boat electrofishing sampling began in July 2007 after repairs were made to equipment.

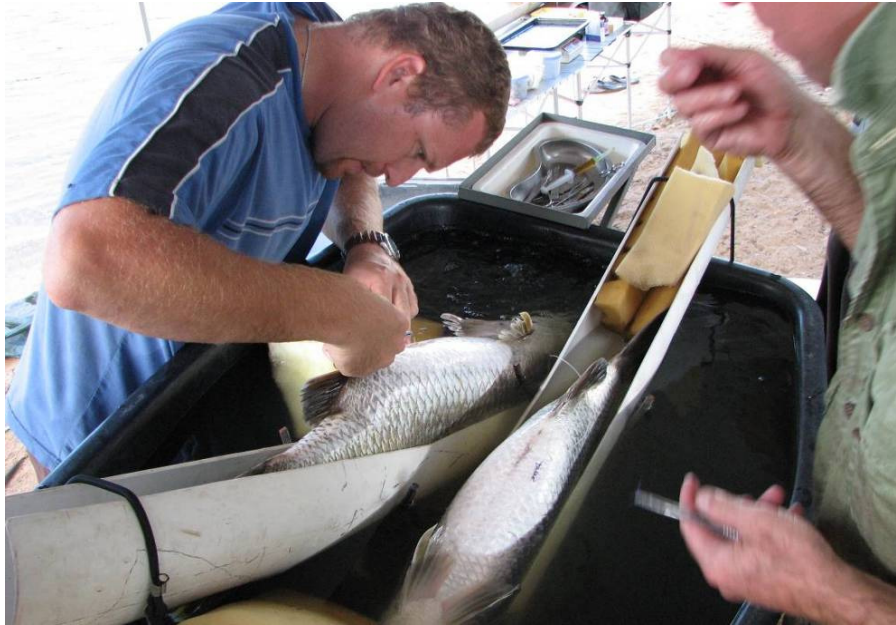
**Figure 8** Radio-tag implantation of barramundi showing surgical mounting boards and aeration tanks.

Prior to surgery, fish were placed into an anaesthetic solution of AQUI-S at 60 mg/L concentration for a period of time to render them unconscious. Once unconscious, fish were placed into custom made surgical boards ensuring that their gills were submerged (Figure 8). Aeration of the surgery tank was supplied to maintain adequate oxygenation of the water. All equipment including the radio transmitters and surgical instruments used in the surgical procedure were sterilised with ethanol.

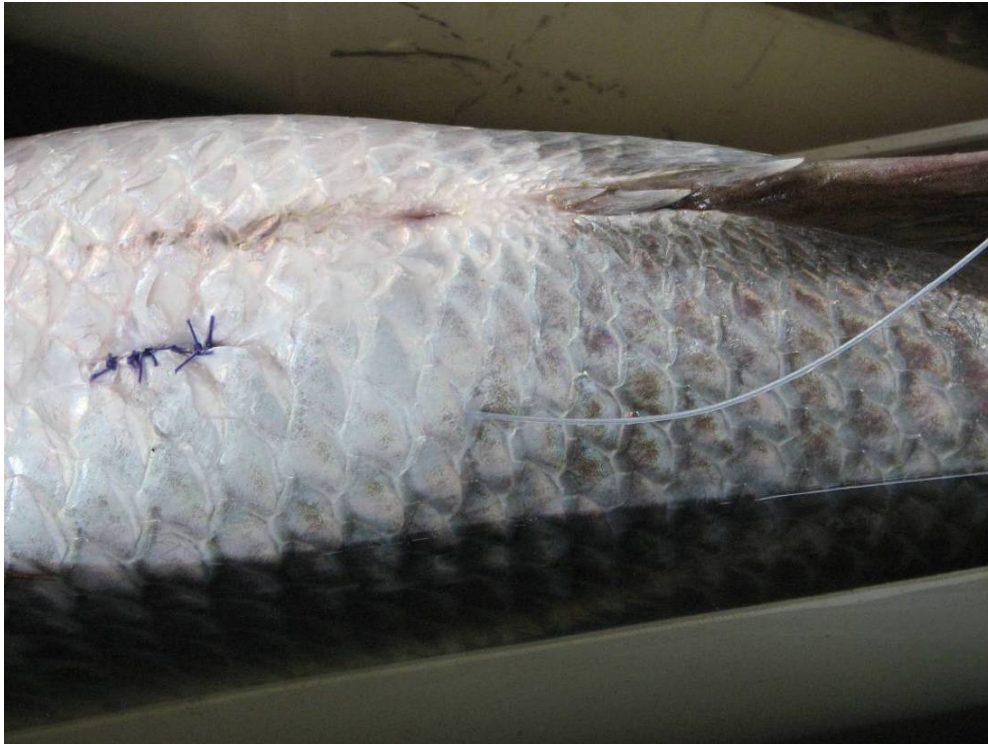
**Figure 9** Radio-tag implantation site showing sutures in an adult barramundi. Note the radio-tag aerial on the right side.

Coded microprocessor radio transmitters were surgically implanted into the body cavity of anaesthetised fish via a small incision through the ventral cavity wall using an established methodology (Koehn and Nicol, 1998). The incision was closed with surgical sutures and fish injected with oxytetracycline as a broad-spectrum antibiotic to aid in the healing process. Figure 9 shows the tag site of a barramundi after suturing. All radio-tagged fish were also implanted with a PIT tag and external plastic t-tag. Fish were then placed within a holding cage until they recovered from the anaesthetic and were released into the river once normal respiration and swimming behaviour was observed. Figures 10 and 11 show adult catadromous fish after surgery prior to release.

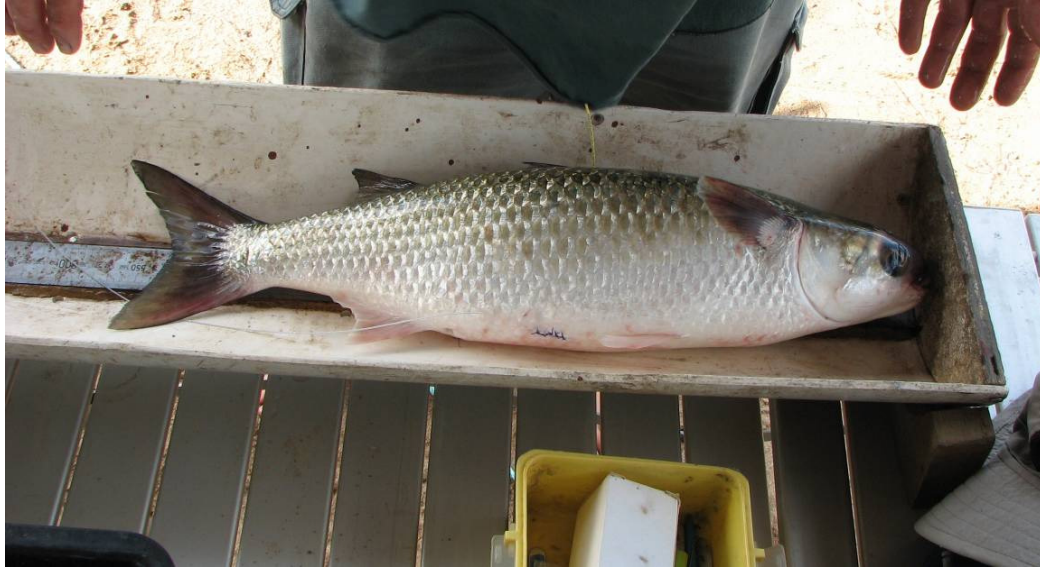
**Figure 10** A post operative adult striped mullet before being released into the holding cages for recovery.

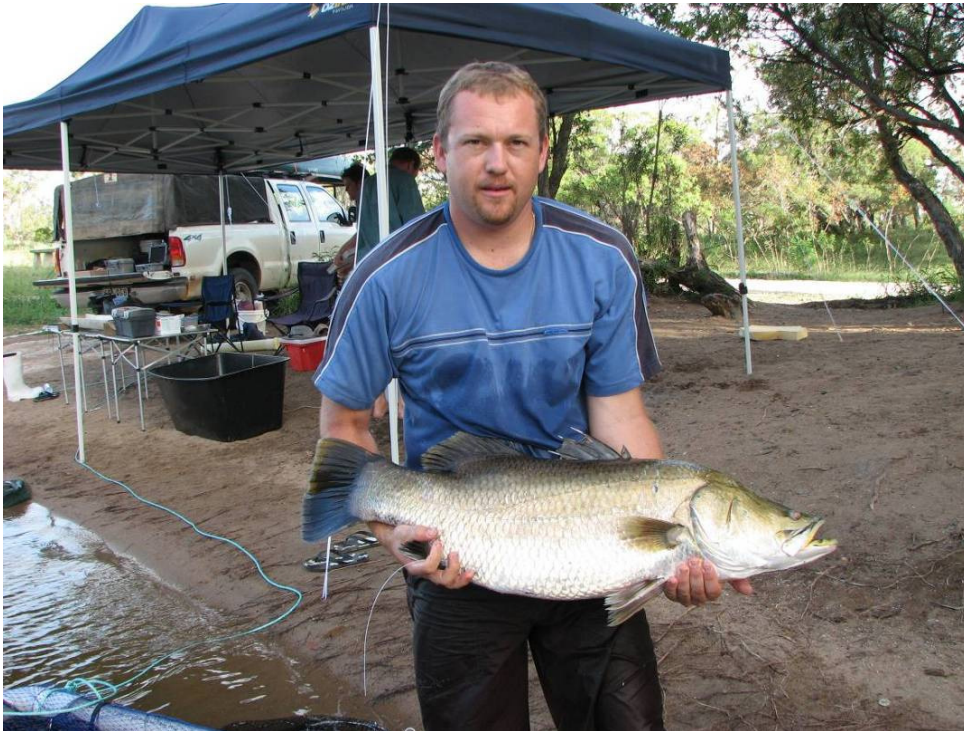
**Figure 11** A post operative barramundi before being released into the holding cages for recovery.

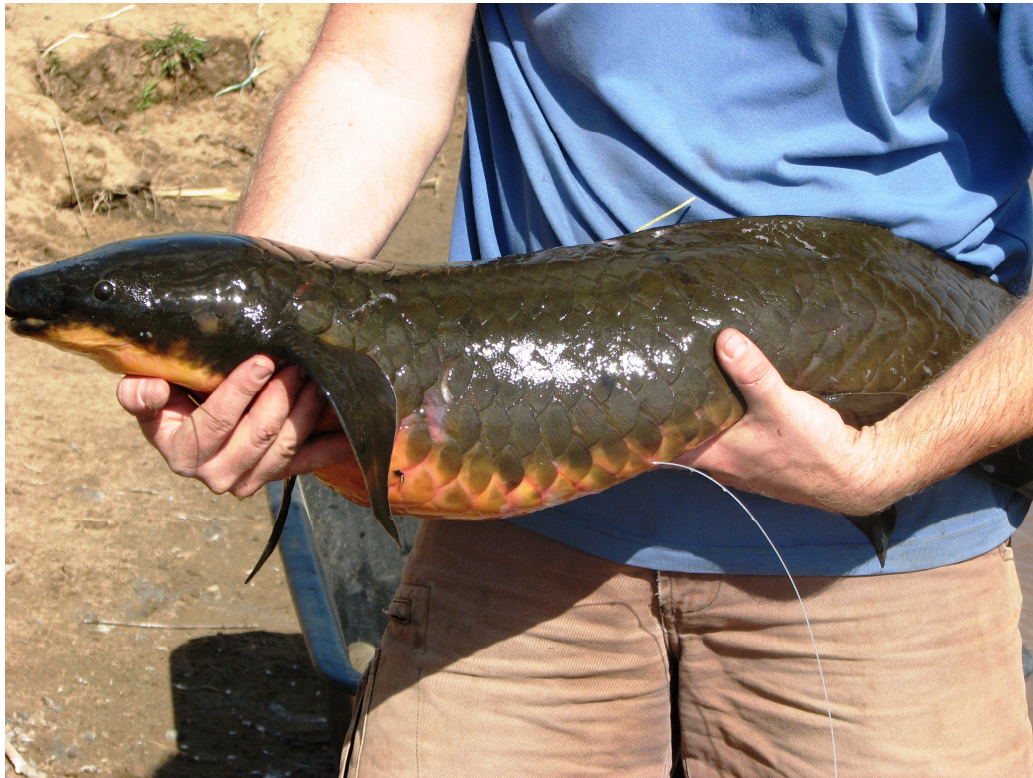
**Figure 12** A post operative lungfish prior to being released into the impoundment.

Queensland lungfish were collected from two separate sites to study their behaviour with regards to downstream migration. Fifteen lungfish were captured 4 to 8 km upstream of the dam wall and after radio tagging were released at the Old Kalliwa Camping Ground, 4.5 kilometres upstream of the dam wall. The other 15 lungfish were captured approximately 9 to 13 km downstream of Paradise Dam at Cherelly Orchard and after radio tagging were translocated to within the dam impoundment. These translocated lungfish were released at the temporary boat ramp 700 metres upstream of the dam wall. This group of lungfish was translocated within the dam to observe if they displayed home ranging behaviour by trying to return downstream. Figure 12 shows a post operative lungfish prior to release.

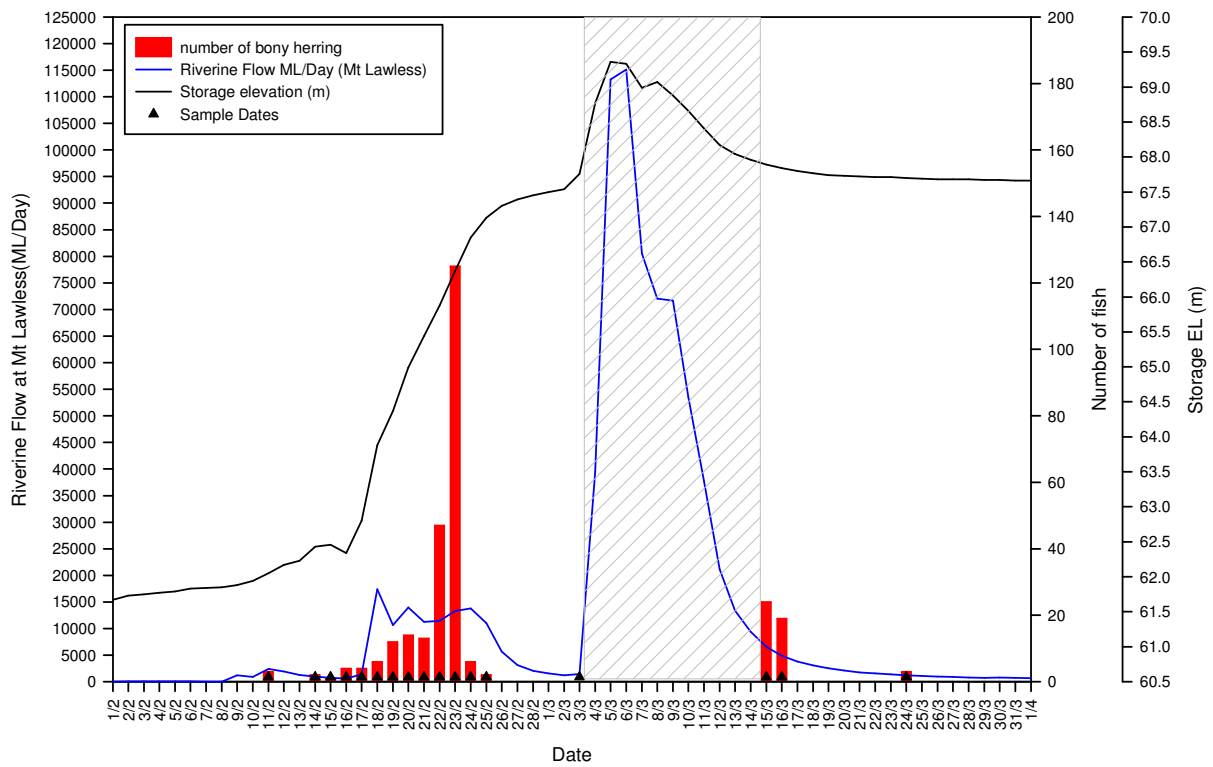
**Figure 20** Number of bony herring using downstream fishway during inflows to Paradise Dam in February/March 2010.

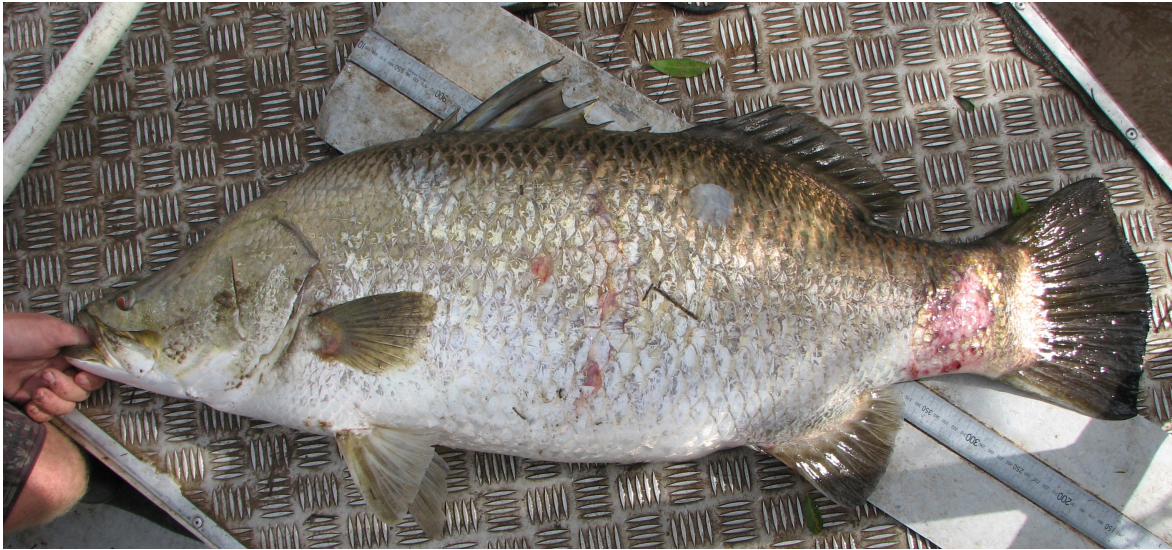
**Figure 25** Live barramundi captured downstream of Paradise Dam showing damage to body and

tail that is beginning to heal.

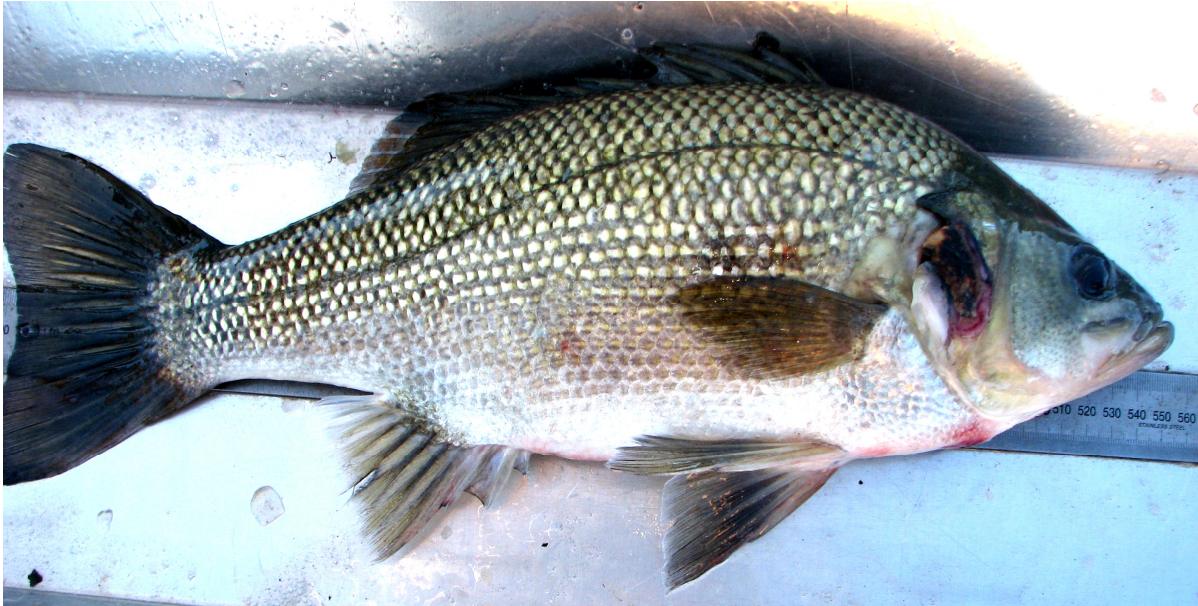
**Figure 27** Live Australian bass captured downstream of Paradise Dam showing damage to head, *N.B.* opercula cover was completely absent.

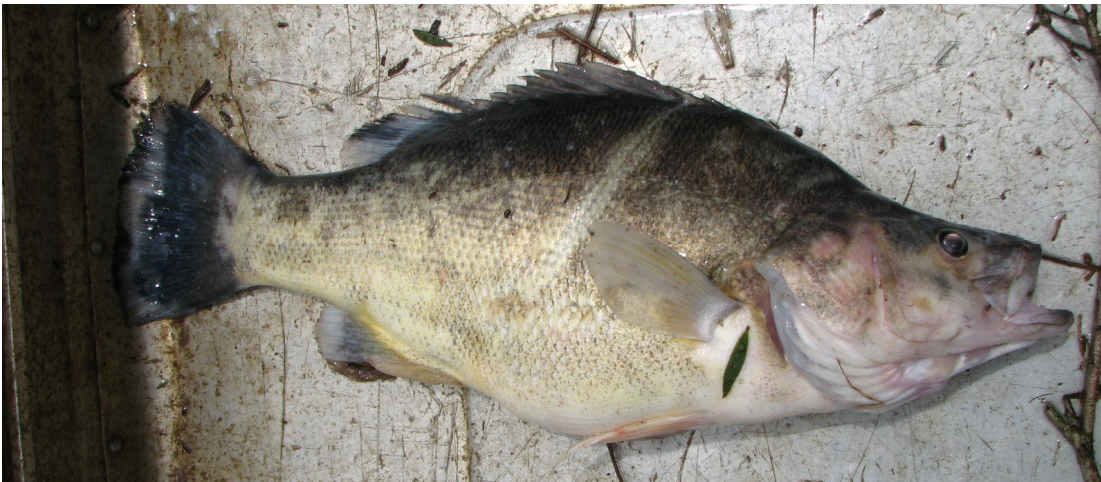
**Figure 28** Deceased golden perch that was collected downstream of the Paradise Dam spillway on the 11<sup>th</sup> March 2010. Note the strike mark extending from the dorsal to the ventral area.

The types of injuries recorded on larger fish such as Queensland lungfish, striped mullet and golden perch were severe. Many of the injured and deceased fish collected exhibited defined lines of injury across their bodies as shown in Figure 28. It is apparent that these injuries are associated with striking a sharp edged surface and is highly possible that they were caused by the spillway steps.

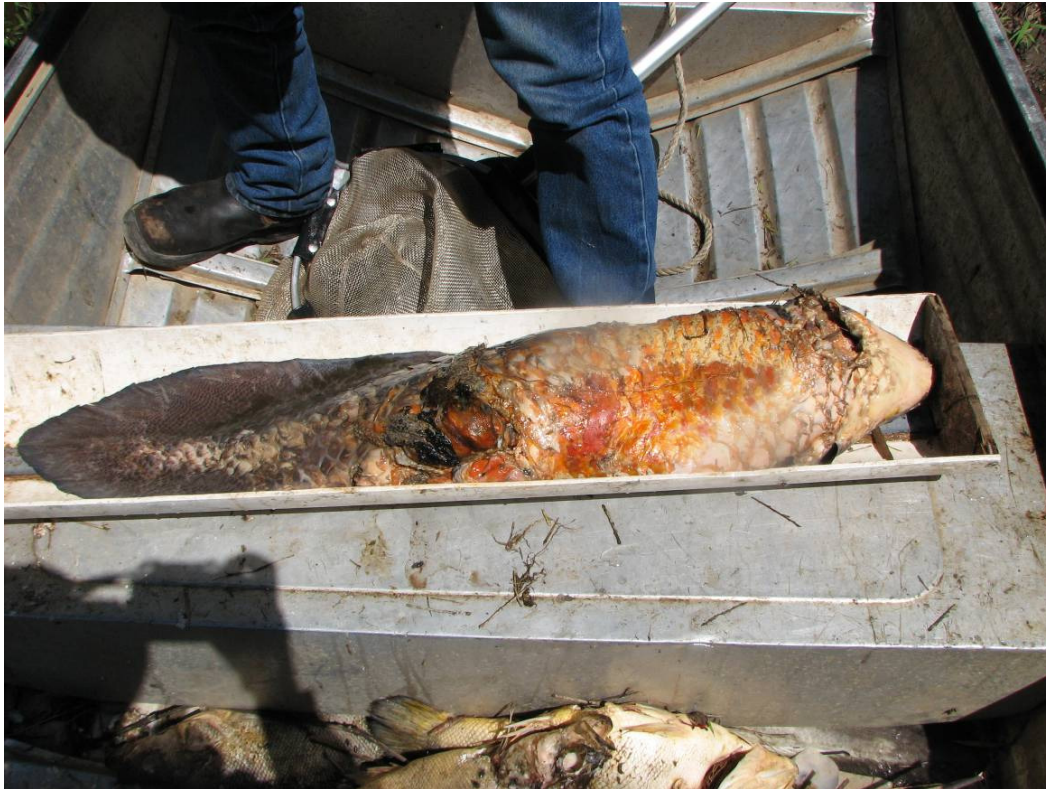
**Figure 31** A deceased Queensland lungfish displaying severe injuries collected after releases made through the environmental tower on the 15<sup>th</sup> September 2010.

Prior to the March and September overtopping events, releases from the environmental tower were made. During these releases deceased fish from eight large bodied species and several small bodied species were collected. Injuries to these fish were generally more severe than those observed in fish which had passed over the spillway.

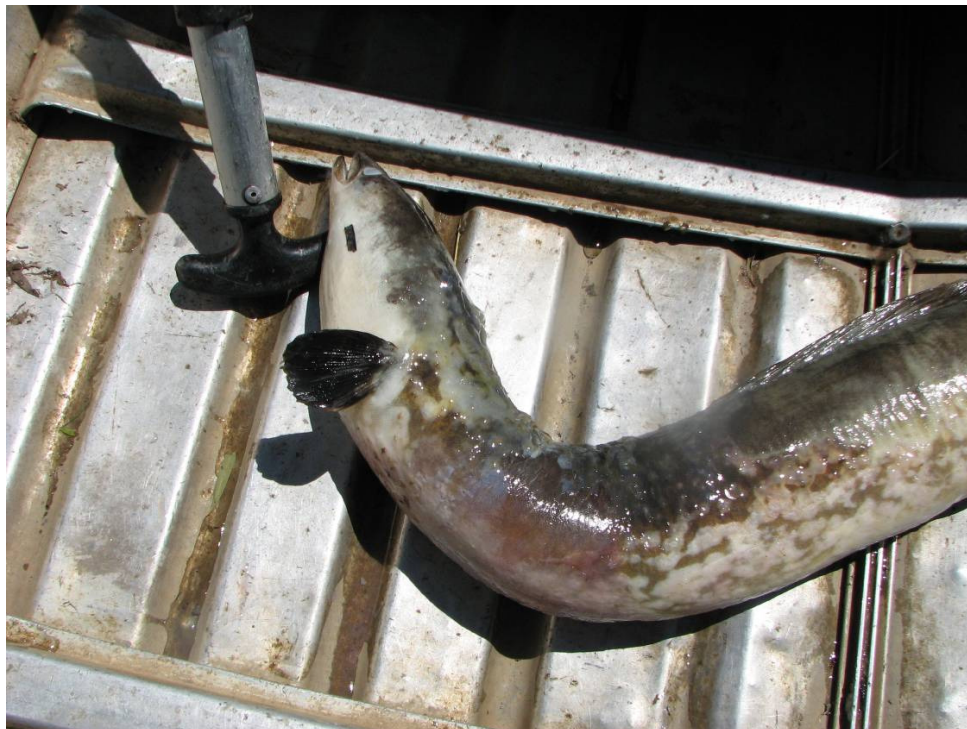
**Figure 32** A deceased long-finned eel with a broken spine collected after releases made through the environmental tower on the 15<sup>th</sup> September 2010.

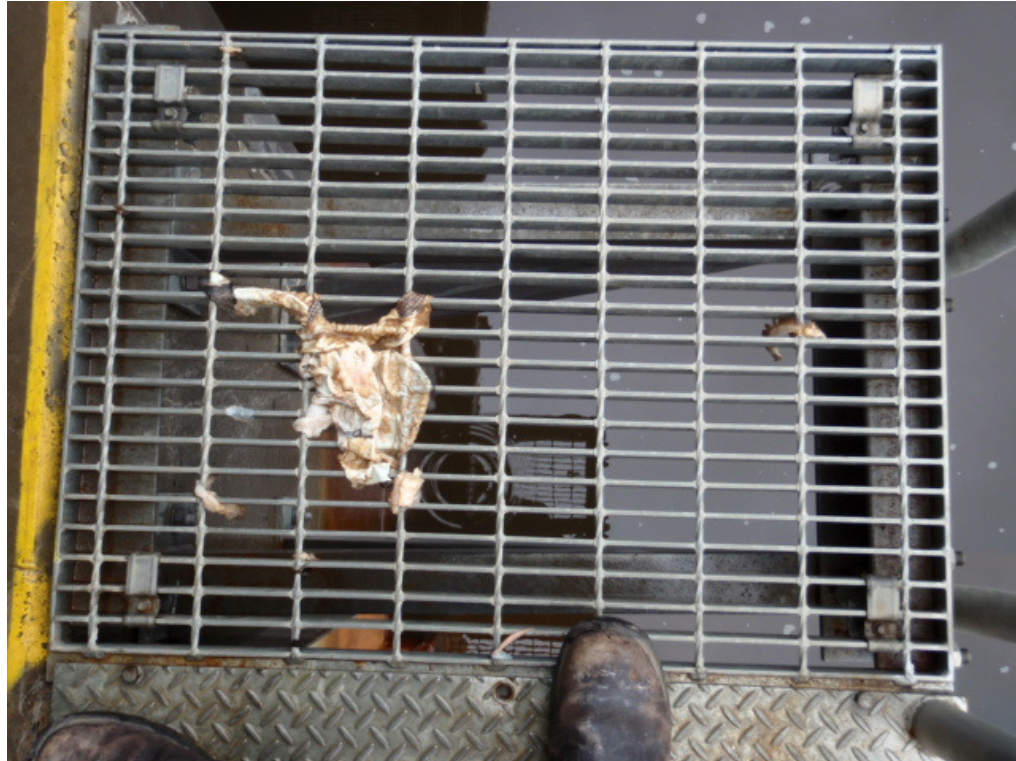
**Figure 33** Pieces of fish found directly at the release point of the environmental tower immediately after being shut down.

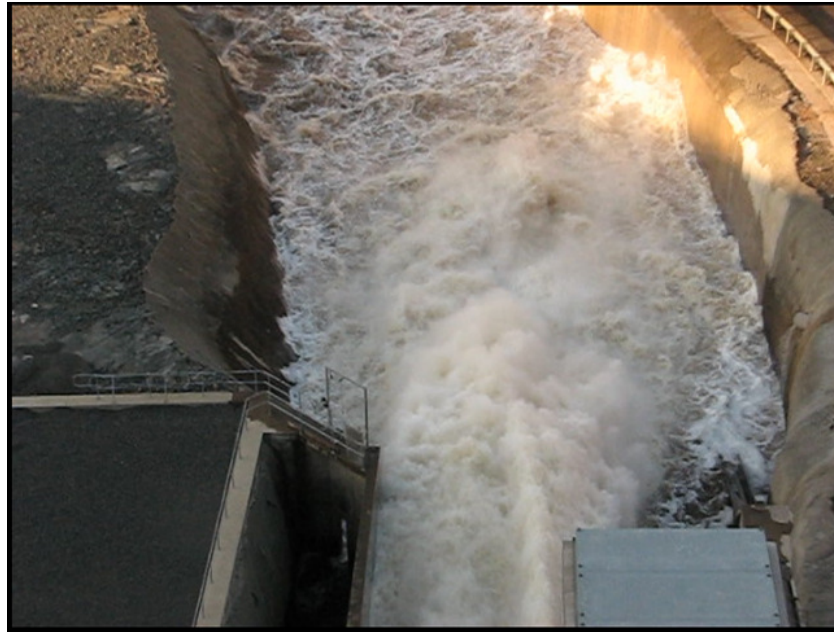
**Figure 34** Fishlock exit conditions during an environmental outlet tower release of 40 cumecs. N.B. Fishlock exit chute is shown in the bottom right corner of the image.

Once the fishway was able to be operated it did so for the majority of the time that water was released from the dam. Non-operational periods were due to mechanical failure or unsuitable exit conditions. The mechanical failures predominantly occurred early in the operation of the fishlock and may be considered part of the wet commissioning process. Unsuitable fishway exit conditions occurred when the environmental release tower was operated at discharges greater than 20 cumecs. At higher flow releases the water jet creates a highly turbulent zone in front of the fishlock exit which is likely to disorient and possibly injure fish that are released from the fish lock (Figure 34).

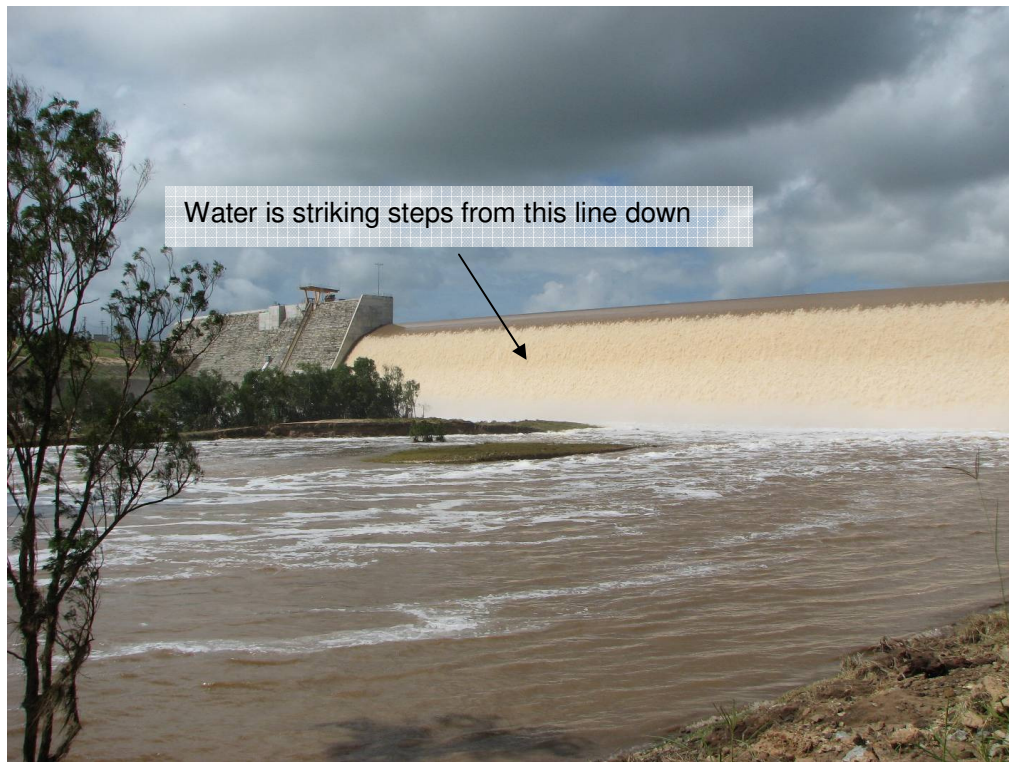
**Figure 35** Flows over Paradise Dam at 10 am on the 10th March 2010 at approximately 1.03 m above full supply.

Minor fish kills associated with spillway flows have occurred at other sites in the Burnett River but not to the extent observed at Paradise Dam in March and September 2010. At Ned Churchward Weir following a flow event in February 2003, dead fish consisting mostly of bony herring and blue catfish, with some striped mullet and long-finned eel, were observed by the authors for a short distance downstream of the weir. All of the fish observed did not display the above mentioned defined lines of injury seen at Paradise Dam. No deceased Queensland lungfish or barramundi were observed following the February 2003 flow event or at any other spillway flow event observed by the authors.
